Before the Fall: Lifecycle Maintenance of Plaster on Wood Lath Ceilings

Conference for Catholic Facility Management (CCFM)

**By Neal Mednick, representing
John Tiedemann Inc. &
Historic Plaster Conservation Services USA**

Austin, Texas / April 10, 2018

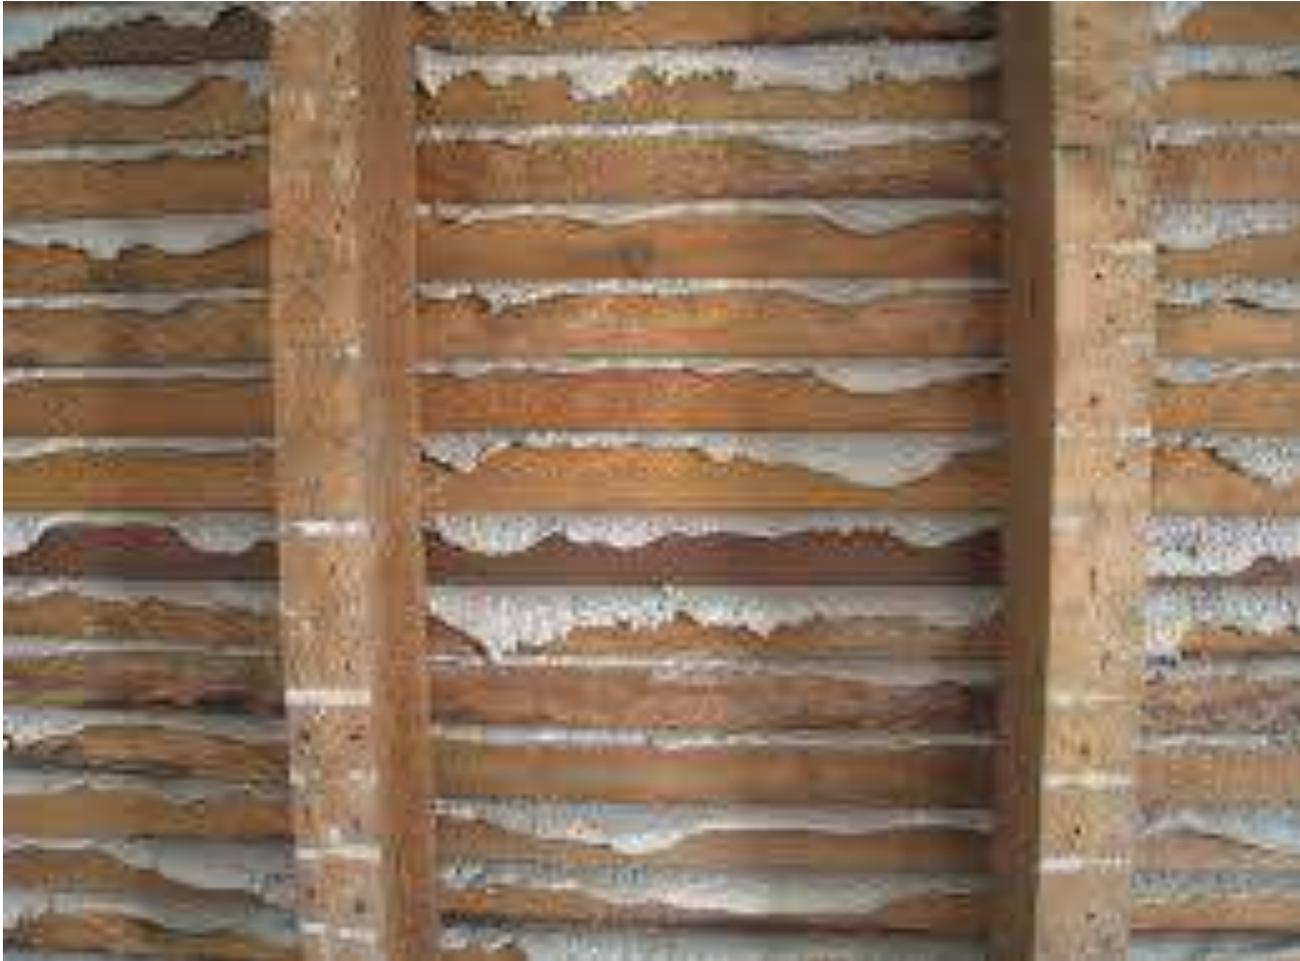
A plaster on wood ceiling functions as a suspended system held up by keys & lugs

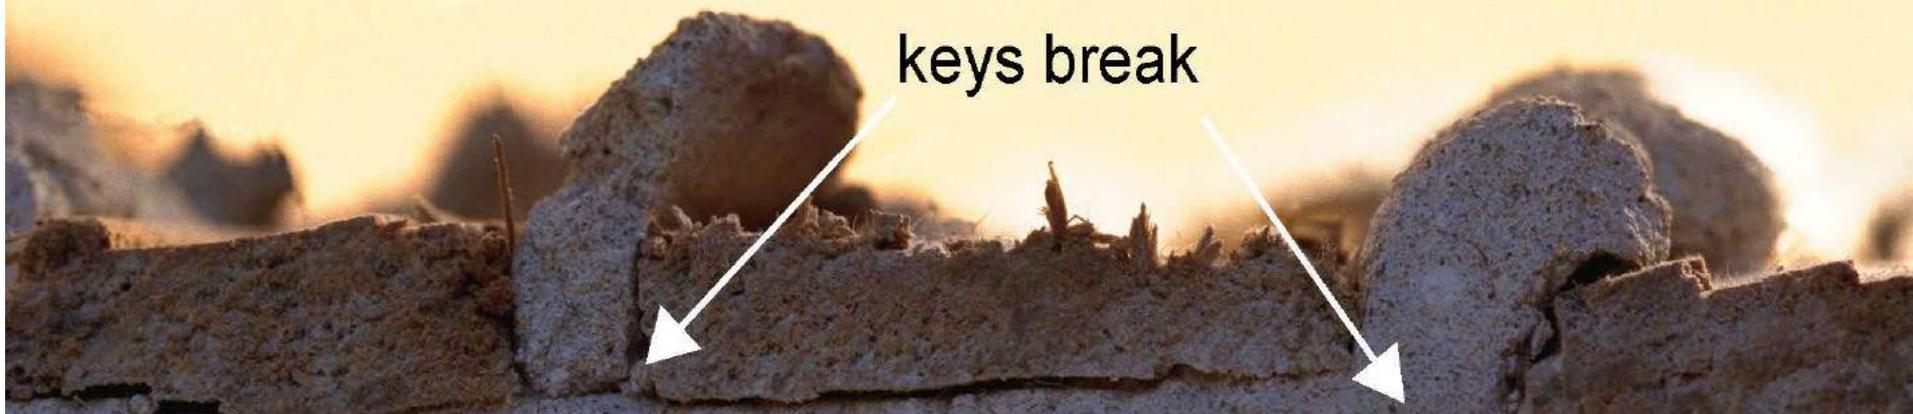
Systemic Deterioration of Plaster on Wood Lath

Warm moist air rises through the plaster as a vapor. In warm conditions, it liquefies and mobilizes soluble salts within the plaster mix. These salts crystallize, forming efflorescence on the surface, which indicates significant structural damage to the plaster matrix.

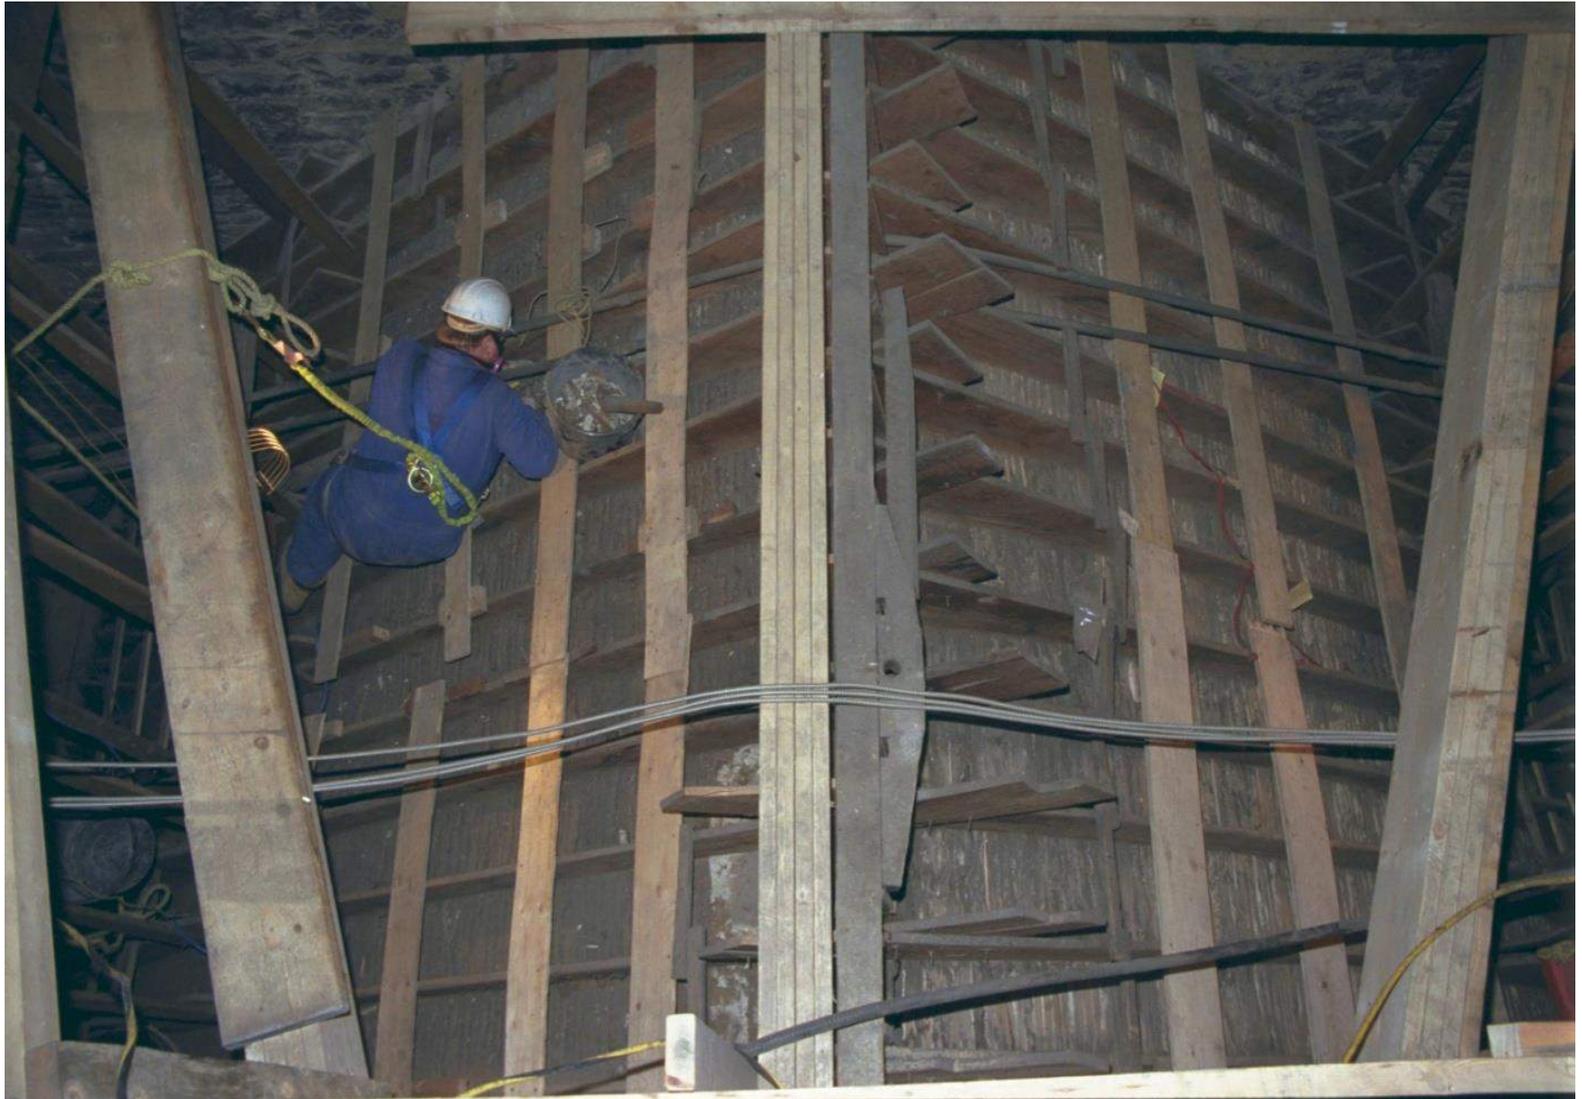
Overview of a typical church attic (safety at all times)

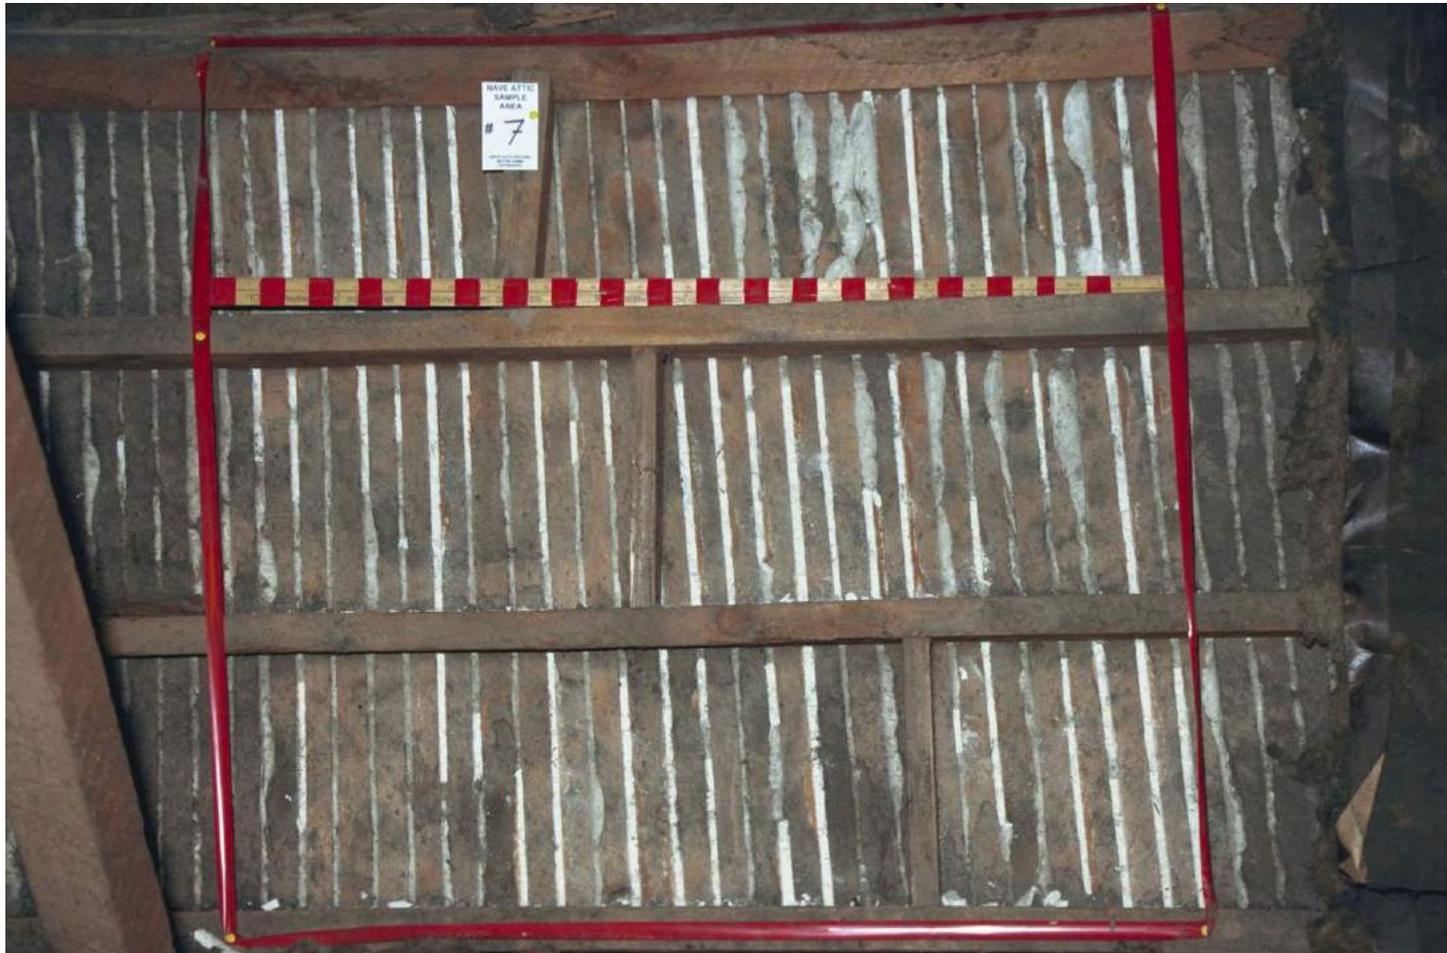
1. Sample Test Area
2. Measure all keys (inches)

1. Sample test areas – 1% to 2% of total area
2. Measure all potentially good keys (in inches)
3. Record on test data card
4. Pull test and measure every broken or missing key in test area (in inches)
5. Record on test data card.
6. Tabulate and extrapolate numbers
7. Calculate condition of the plaster.

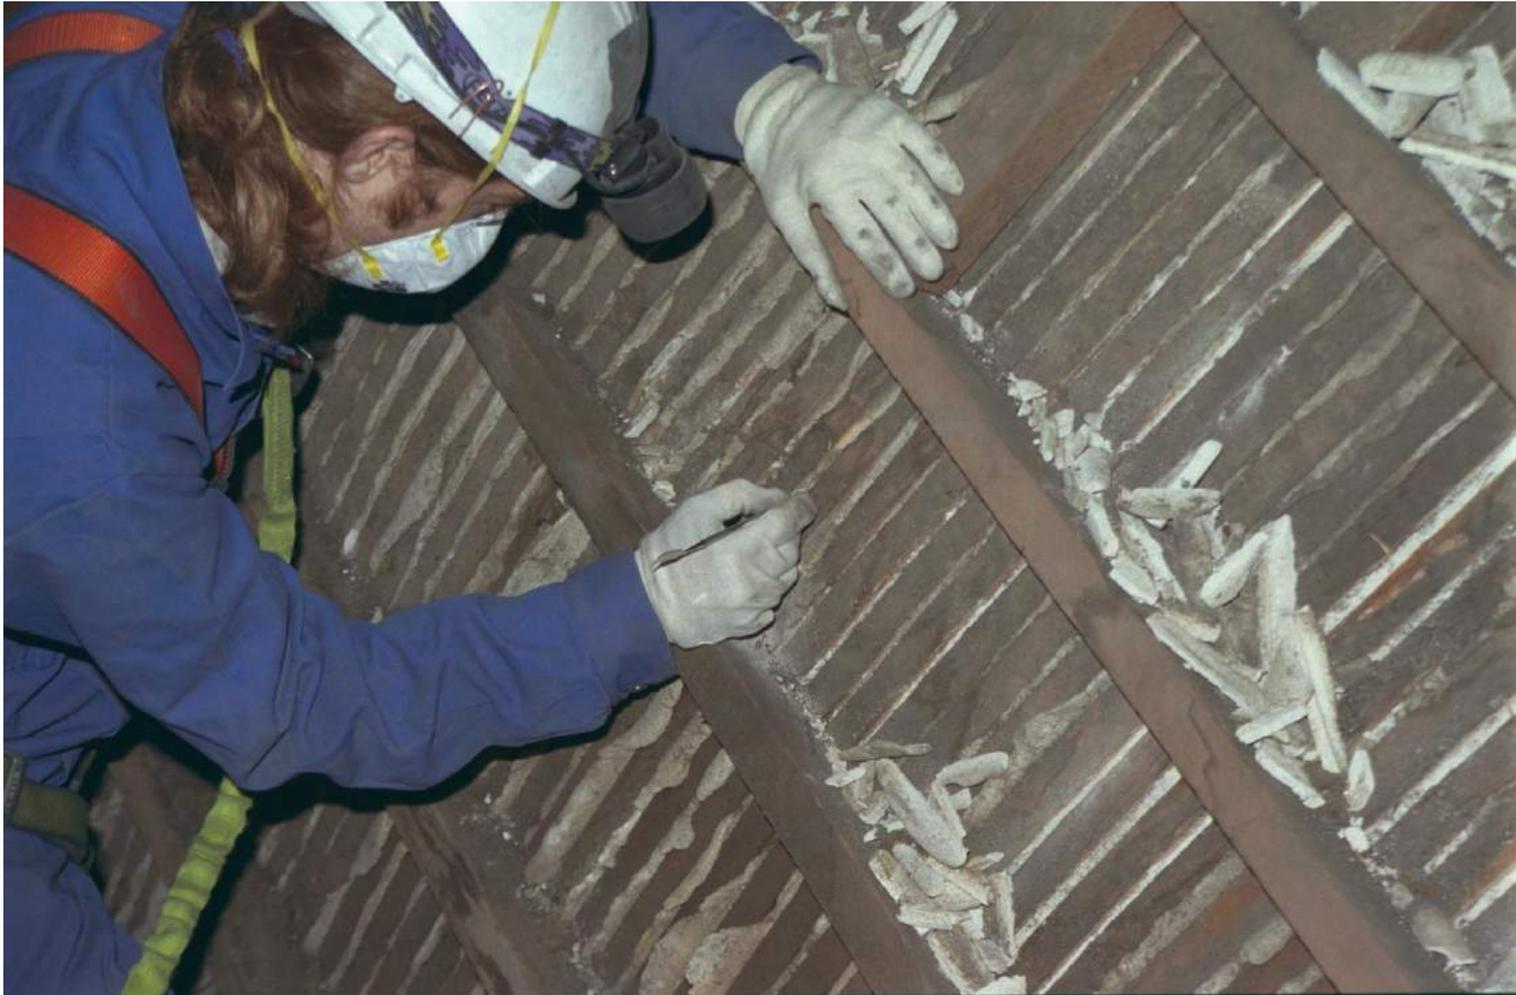
Remove broken keys or lugs from the test area, measure each and record total number of linear inches on Test Data Card.

Every key within sample area must be tested

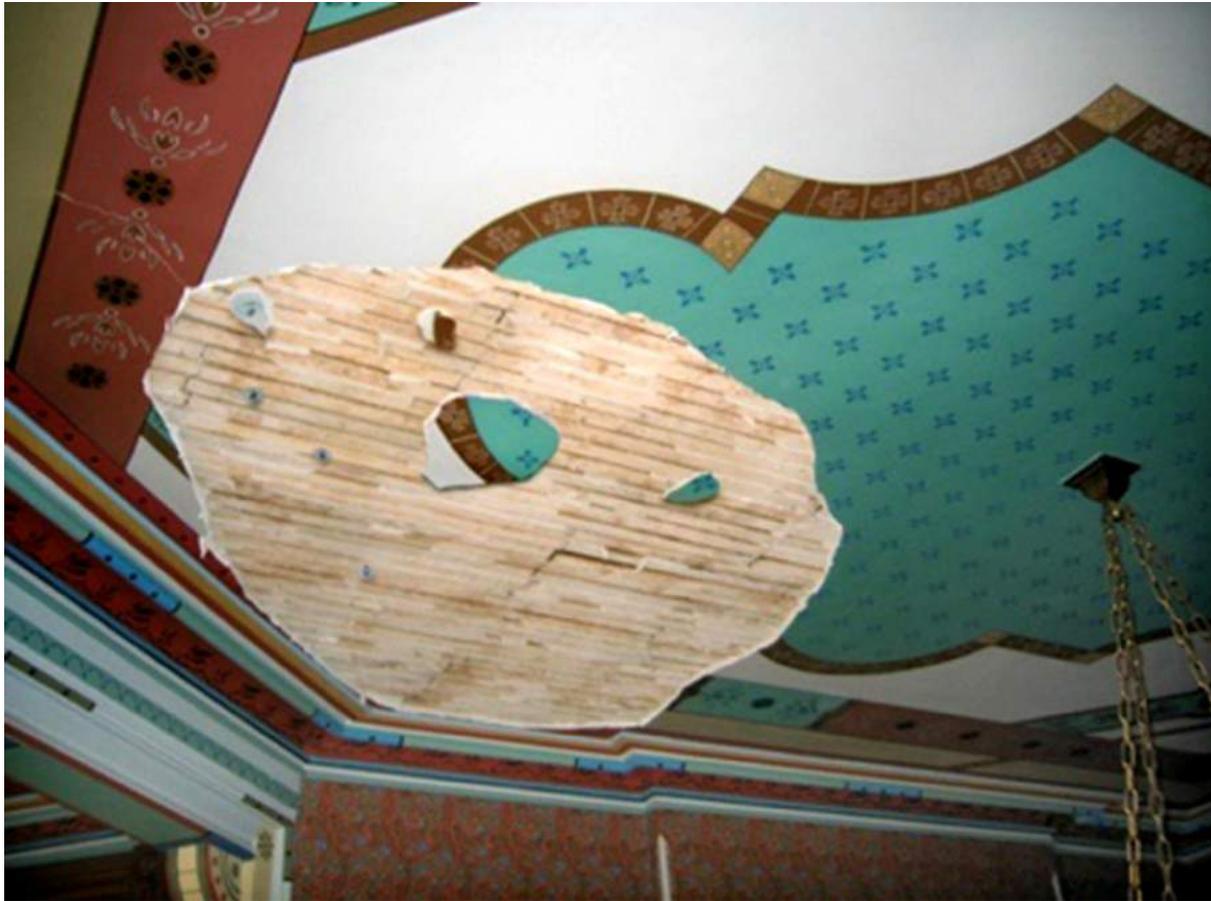
Traditional Treatment Method #2: Wood Screws & Washers

Wood screws & washers are installed across ceiling surface.

Wood screws & washers deface the ceiling surface.

The plaster continues to deteriorate around the points of contact.
