Conference for Catholic Facility Management

What are Facility Condition Assessments (“FCA”), and How Can They Enhance Your Understanding of Your Facilities? SAV1506

Matthew Munter, P.E.
May 12, 2015

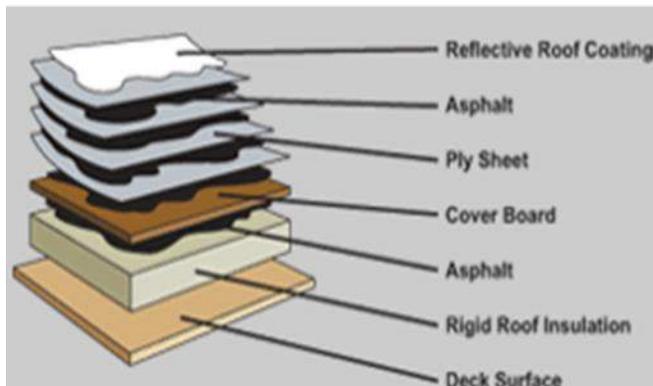
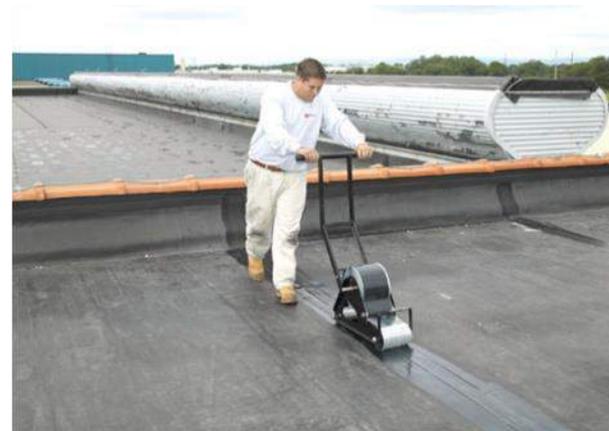
Typical Detail on Roofing

Assessment identifies:

- Material roof systems (exposed membrane and flashings)
- Slope and drainage
- Oriented Strand Board (OSB) damage
- ponding or leaks
- Seam/lap failure
- Ridging, blistering
- Deterioration, “alligatoring”

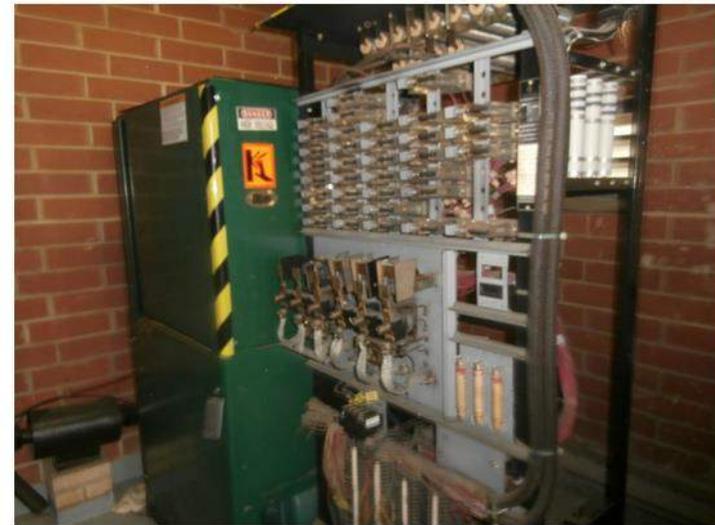
| Comments: | The elevator machinery and controls are the originally installed system in 1976 and are beyond expected useful life. Based on its estimated Remaining Useful Life (RUL), the elevator equipment will require replacement during the assessment period. |
